# RESEARCH MEMORANDUM

INVESTIGATION OF CERAMIC, GRAPHITE, AND CHROME-PLATED  
GRAPHITE NOZZLES ON ROCKET ENGINE

By George R. Kinney and William G. Lidman

March 7, 1949

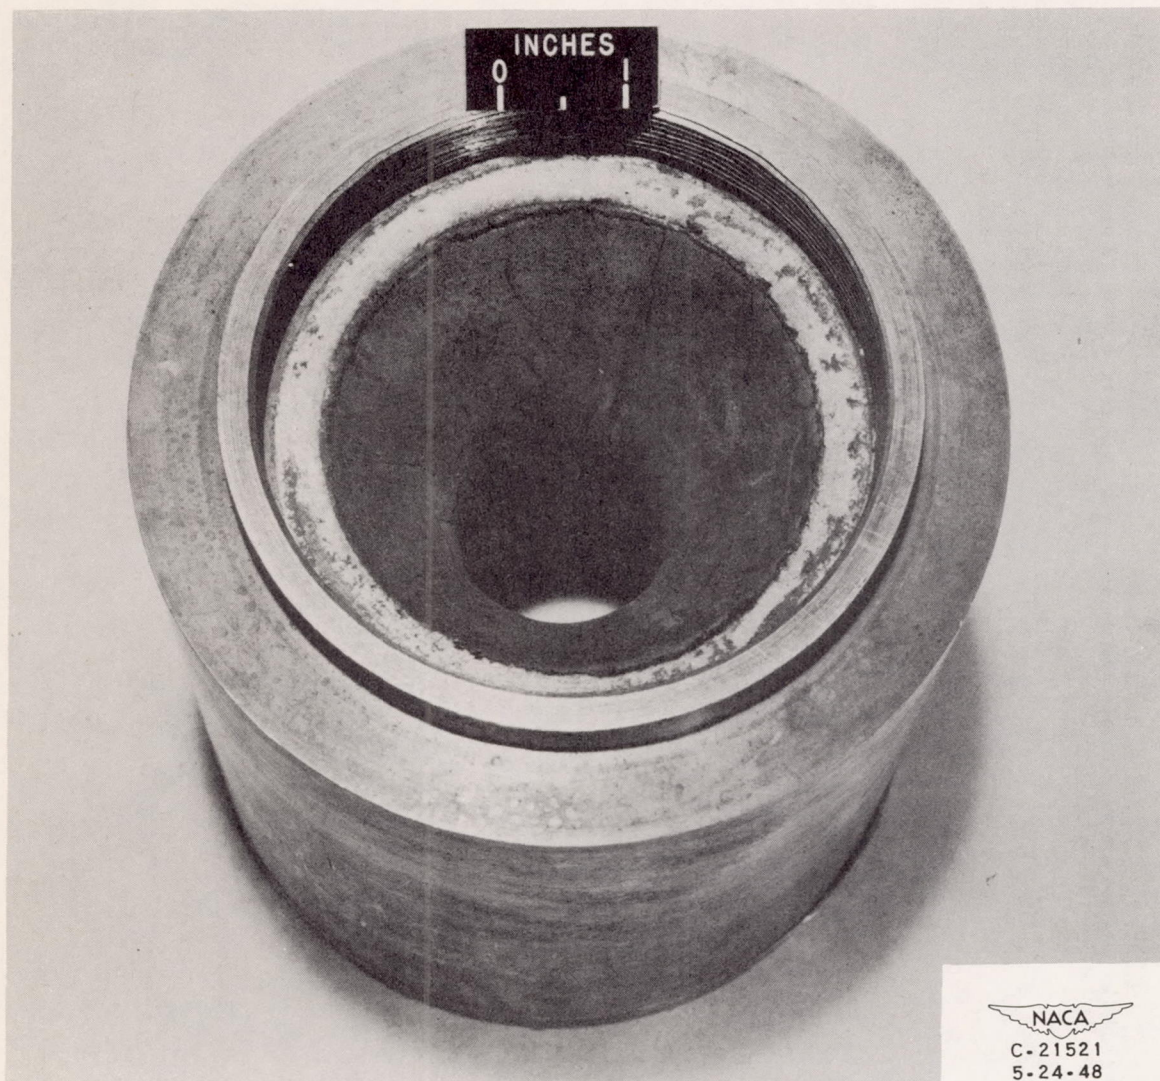
Ceramic nozzle. - The ceramic rocket nozzle after run 1 (16-sec operation, fuel-rich mixture, estimated gas temperature of 2000° F) is shown in figure 2. The cracking in the convergent section, which was caused by thermal shock, can be seen. No appreciable erosion at the throat and no cracking in the divergent section occurred. The same ceramic nozzle after run 2 (10-sec additional operation, near stoichiometric mixture ratio, estimated gas temperature of 2400° F) is shown in figure 3. No further cracking occurred and the condition of the nozzle was little changed by the second run. The nozzle apparently withstood the second thermal shock without further damage. The effect of further operation on erosion or cracking was not investigated. Results of a similar nature are presented in reference 1 where it was observed that a ceramic lining for a combustion chamber cracked but did not fall apart during operation. These results indicate that a ceramic rocket-nozzle liner can be successfully operated after it has cracked if it is properly supported.

| Run | Material | Operation time (sec) | Oxidant-fuel ratio | Combustion pressure (lb/sq in. abs.) | Thrust (lb) | Estimated combustion-gas temperature (°F) | Nozzle-outer-surface temperature at throat (°F) | Condition of nozzles after operation |
|---|---|---|---|---|---|---|---|---|
| 1 | Ceramic containing high percentage of sillimanite with aluminum oxide enriched glaze | 16 | 2.5 | 285 | 944 | 2000 | 1100 | Cracked in convergent section, otherwise undamaged |

Figure 2. - Ceramic rocket nozzle after run 1 showing condition of convergent section.  
Operation, 16 seconds; fuel-rich mixture; estimated gas temperature, 2000° F.

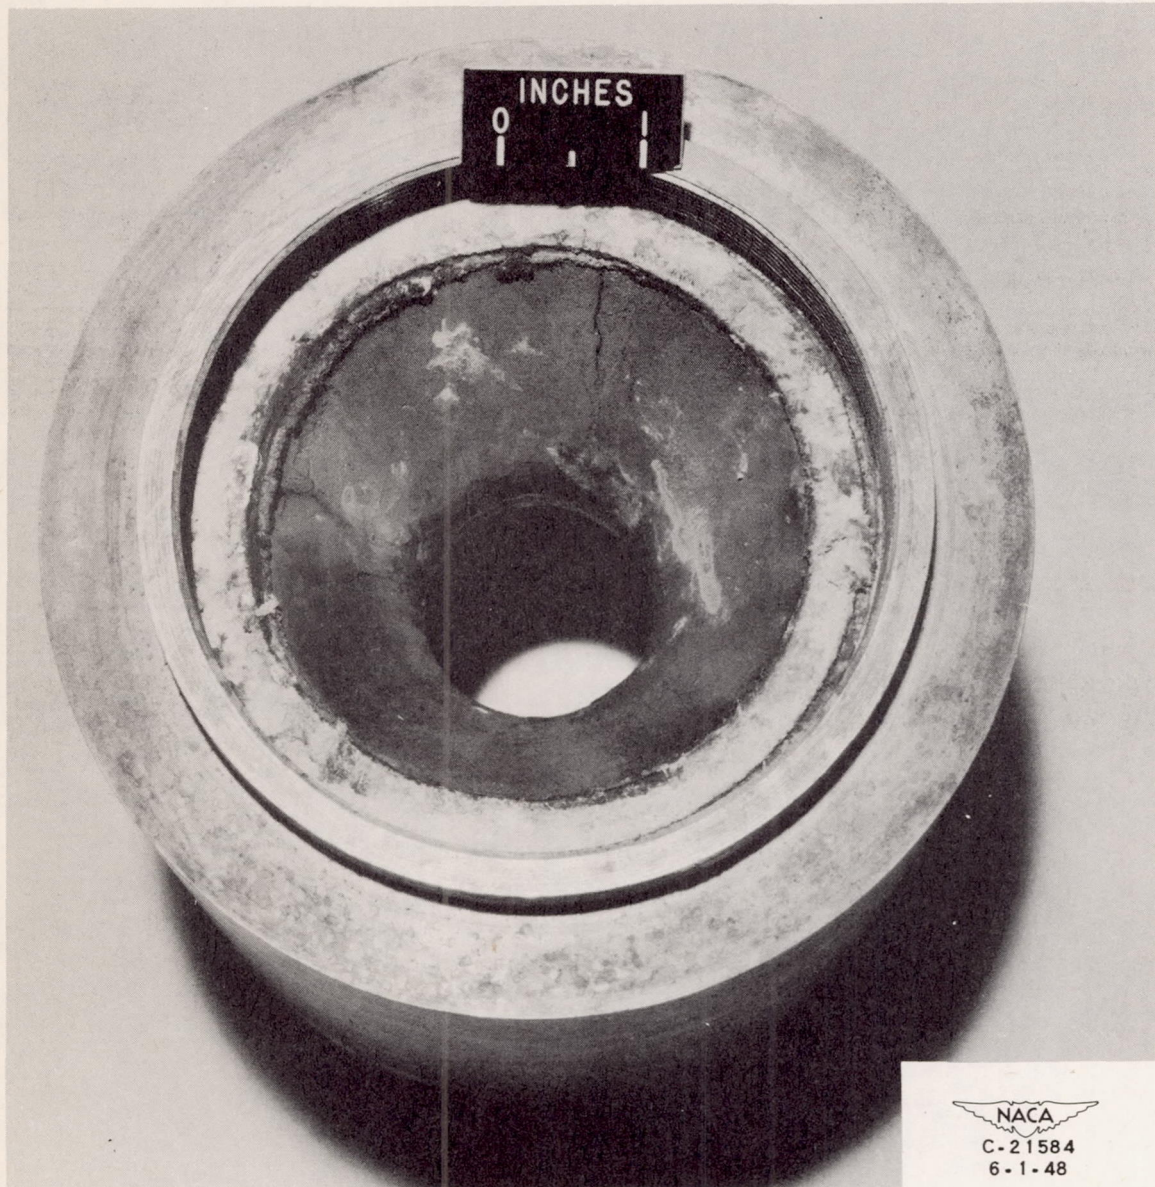
| Run | Material | Operation time (sec) | Oxidant-fuel ratio | Combustion pressure (lb/sq in. abs.) | Thrust (lb) | Estimated combustion-gas temperature (°F) | Nozzle-outer-surface temperature at throat (°F) | Condition of nozzles after operation |
|---|---|---|---|---|---|---|---|---|
| 2 | Same nozzle after run 1 | 10 | 3.2 | 255 | 911 | 2400 | --- | Same as after run 1 |

Figure 3. - Ceramic rocket nozzle (same nozzle used for run 1) after run 2 showing condition of convergent section. Additional operation, 10 seconds; near stoichiometric mixture ratio; estimated gas temperature,  $2400^{\circ}\text{F}$ .

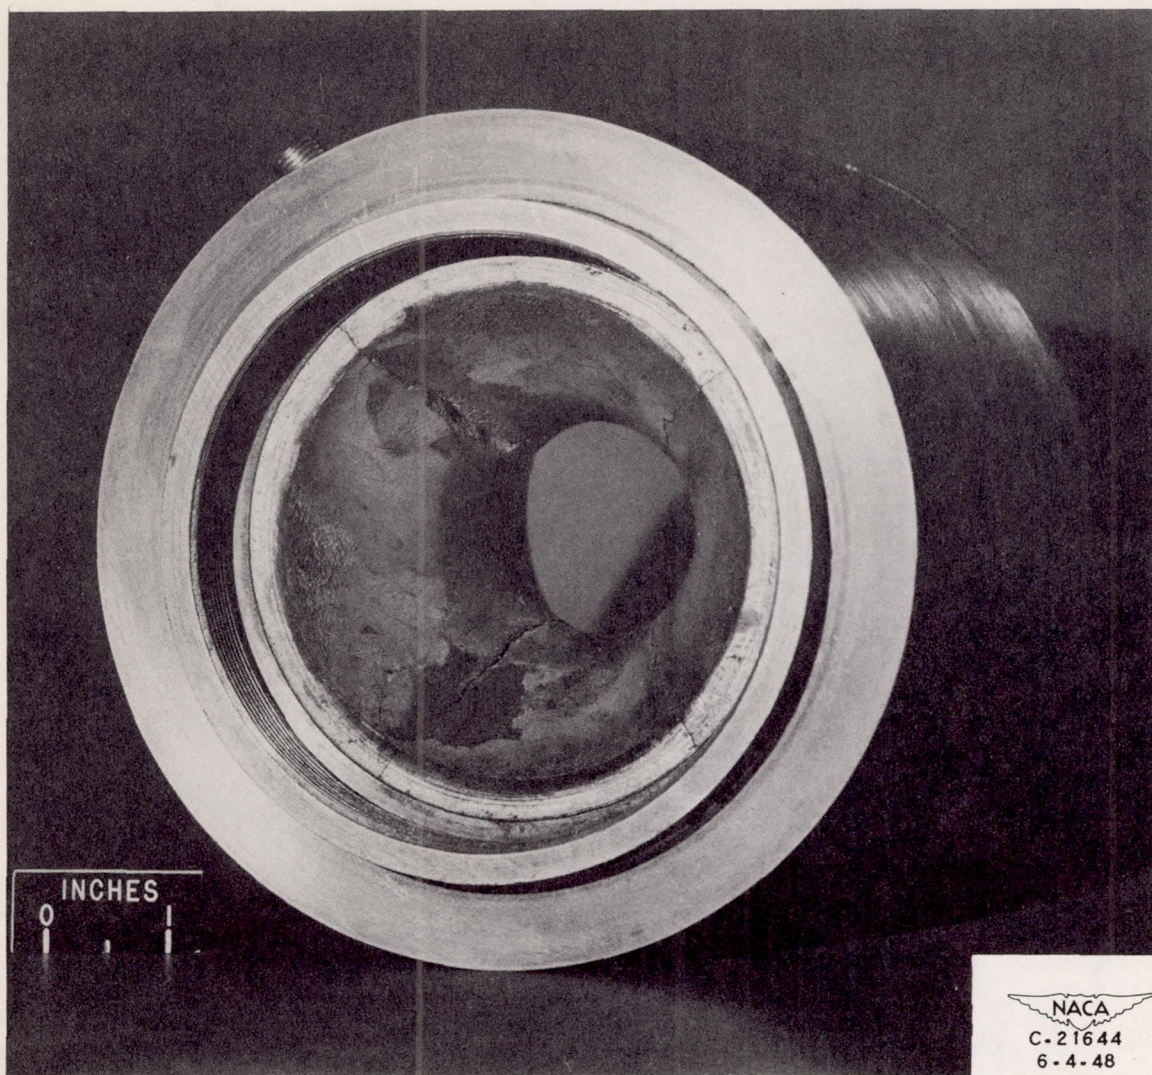
Graphite nozzles. - The graphite nozzle without surface plating is shown in figure 4 after run 3 (17-sec operation, near stoichiometric mixture ratio, estimated gas temperature of 2400° F). The nozzle cracked into four pieces of nearly equal size and erosion at the cracks is considerable. The surface of the graphite shows signs of oxidation and erosion in other regions, especially in the convergent section. The erosion observed near the nozzle entrance between cracks is probably caused by an excess of oxygen at those places, whereas this excess of oxygen has apparently disappeared at the throat. A local excess of oxygen could result from incomplete mixing and combustion in the combustion chamber.

The cracking of the graphite during runs 3 and 5 is attributed to the use of extruded graphite. As the result of the extrusion process, the final graphite product is non-homogeneous and tends to be striated. These striae would cause stresses in the graphite that would in turn cause cracking and fracture when the graphite is subjected to additional stresses. The use of molded graphite will eliminate initial stresses in the material.

| Run | Material | Operation time (sec) | Oxidant-fuel ratio | Combustion pressure (lb/sq in. abs.) | Thrust (lb) | Estimated combustion-gas temperature (°F) | Nozzle-outer-surface temperature at throat (°F) | Condition of nozzles after operation |
|---|---|---|---|---|---|---|---|---|
| 3 | Graphite | 17 | 3.3 | 250 | 887 | 2400 | 330 | Cracked into four nearly equally sized pieces; surface eroded especially at cracks |

Figure 4. - Graphite rocket nozzle without surface plating after run 3 showing surface condition of convergent section. Operation, 17 seconds; near stoichiometric mixture; estimated gas temperature,  $2400^{\circ}$  F.

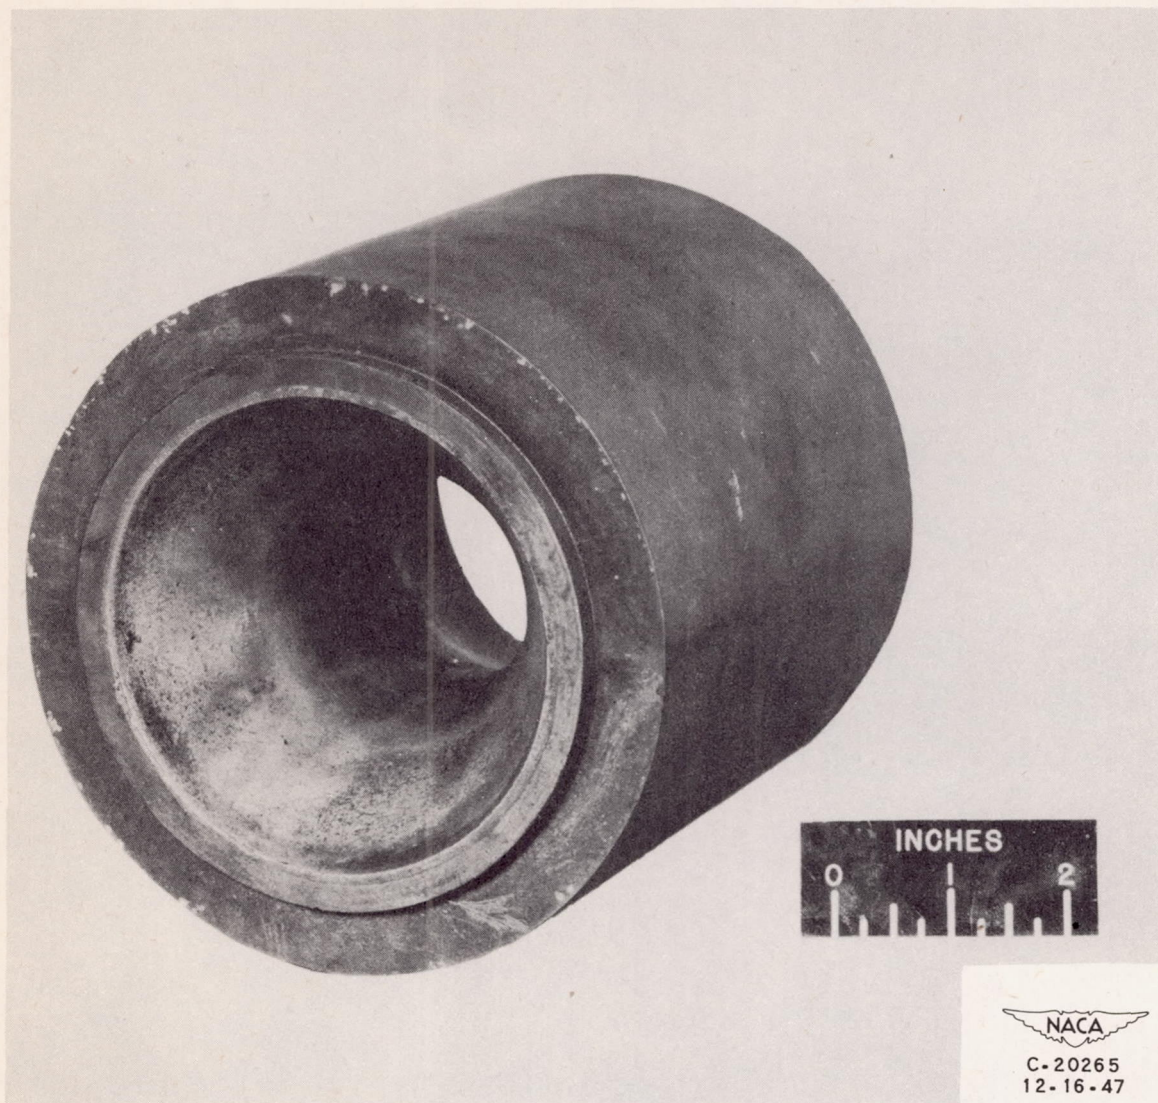
The graphite nozzle with chrome-plated internal surface, which was used during run 4 (19-sec operation, fuel-rich mixture, estimated gas temperature of 2200° F), is shown in figure 5. The chrome-plated surface became pitted but protected the graphite from oxidation and erosion. No cracking of the nozzle occurred. The dark spots, which can be seen on the chrome-plated surface, are pits that contained carbon deposits from combustion.

An X-ray-diffraction analysis was made of the plated surface of the nozzle after run 4 and carbon, chromium, and chromium oxide were present. The diffraction results thus showed that the bond between the graphite and the chromium was physical; no chemical reaction took place between the chromium and the graphite to form chromium carbide, which would have provided a desirable chemically bonded coating. An examination of the nozzles shown by figures 4 and 5 indicated, however, that the physically bonded chrome plate did protect the graphite from erosion and oxidation.

| Run | Material | Operation time (sec) | Oxidant-fuel ratio | Combustion pressure (lb/sq in. abs.) | Thrust (lb) | Estimated combustion-gas temperature (°F) | Nozzle-outer-surface temperature at throat (°F) | Condition of nozzles after operation |
|---|---|---|---|---|---|---|---|---|
| 4 | Chrome-plated graphite | 19 | 1.5 | 265 | 895 | 2200 | 310 | No cracking; chrome plating protected surface from erosion; chromium surface pitted |

Figure 5. - Chrome-plated graphite rocket nozzle after run 4 and removal of combustion deposits from convergent section. Operation, 19 seconds; fuel-rich mixture; estimated gas temperature, 2200° F.

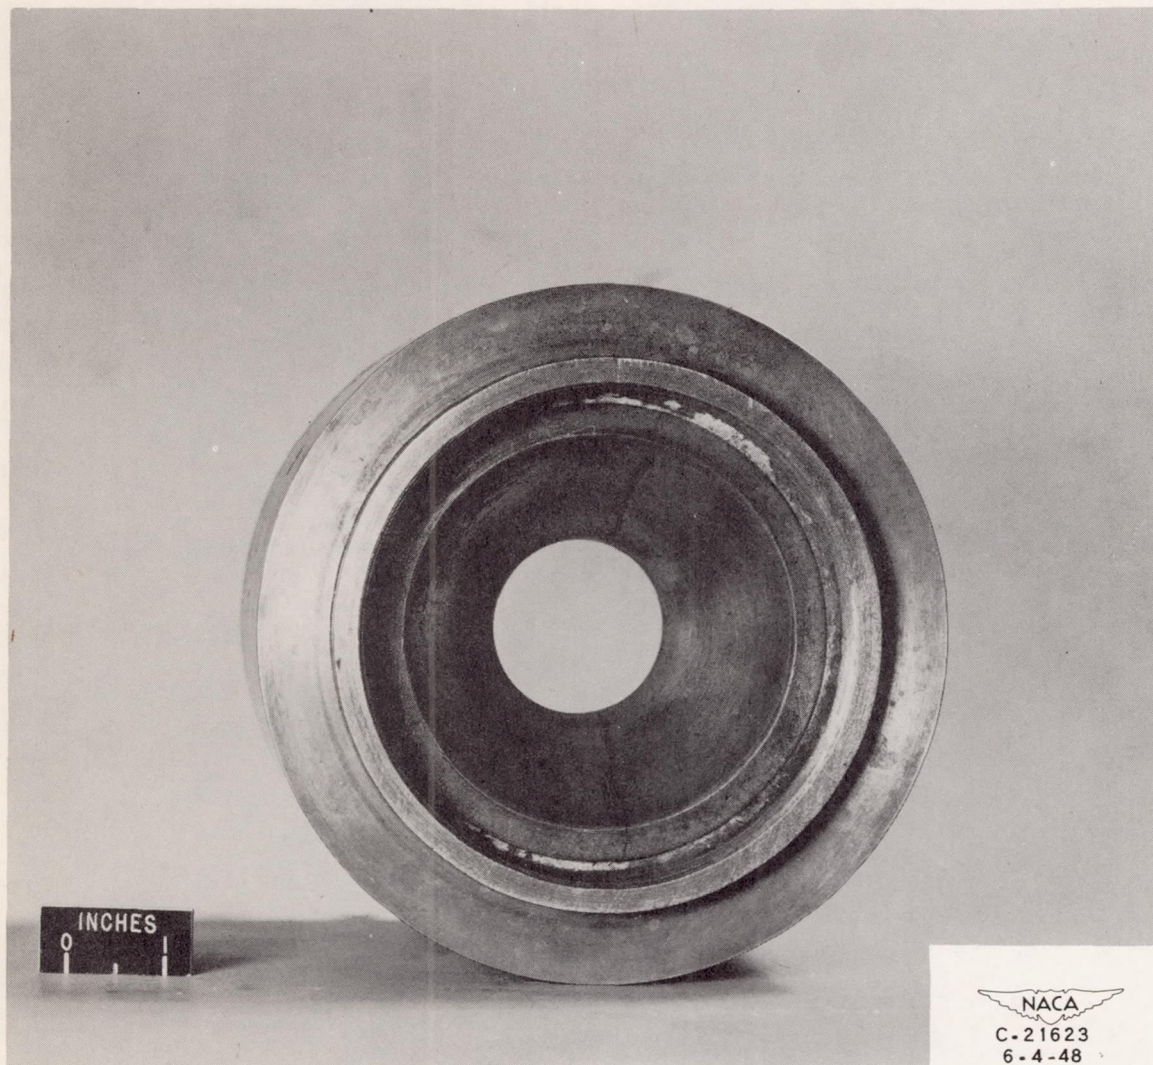
The graphite nozzle with chrome-plated internal surface, which was used for run 5 (17-sec operation, near stoichiometric mixture ratio, estimated gas temperature of 2400° F), is shown in figure 6. The nozzle cracked at three places and was held in shape by the metal housing. The chrome-plated surface was slightly pitted but protected the graphite from oxidation and erosion. The chrome plating was less pitted on this nozzle after a more severe operation than it was on the nozzle used in run 4. The nozzle used for run 5 probably had a better plating than the nozzle used for run 4.

| Run | Material | Operation time (sec) | Oxidant-fuel ratio | Combustion pressure (lb/sq in. abs.) | Thrust (lb) | Estimated combustion-gas temperature (°F) | Nozzle-outer-surface temperature at throat (°F) | Condition of nozzles after operation |
|---|---|---|---|---|---|---|---|---|
| 5 | Chrome-plated graphite | 17 | 3.3 | 263 | 883 | 2400 | 140 | Cracked into three nearly equally sized pieces; chrome plating protected surface from erosion; surface slightly pitted |

Figure 6. - Chrome-plated graphite rocket nozzle after run 5 and removal of combustion deposit from convergent section. Operation, 17 seconds; near stoichiometric mixture ratio; estimated gas temperature,  $2400^{\circ}$  F.
